Article

Thermography Investigation and Seismic Vulnerability Assessment of a Historical Vaulted Masonry Building

Keywords: heritage; in situ testing; structural analysis; FEM; thermography; masonry

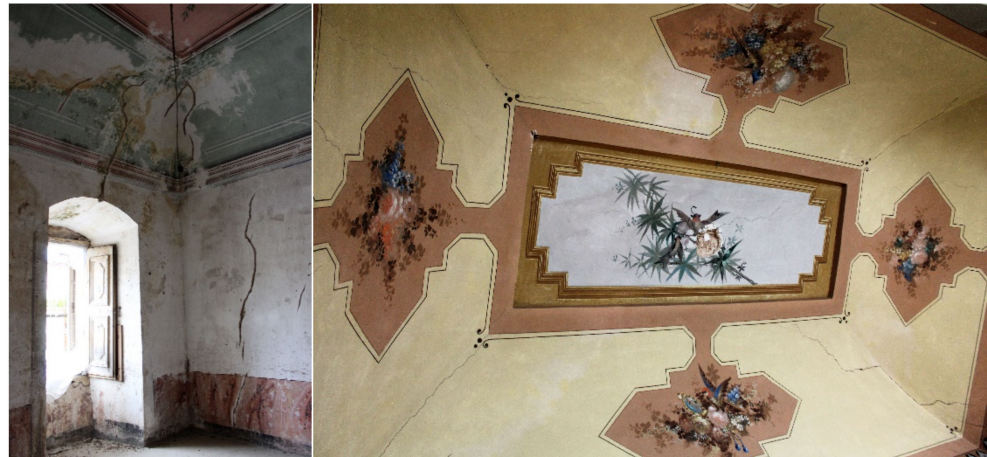
Figure 2. Examples of the crack pattern: corner walls (left) and vault (right).

These aspects have led to the manifestation of crack patterns along with the whole building (e.g., in Figure 2), which is attributable to creep effects whereby the thrusts deriving from the load acting on curved structural elements no longer find equilibrium in the counterthrusts [14]. Consequently, the lowering of the vaults and the out-of-plane rotation of the supporting walls occurred. In fact, the cracks are all comparable with the

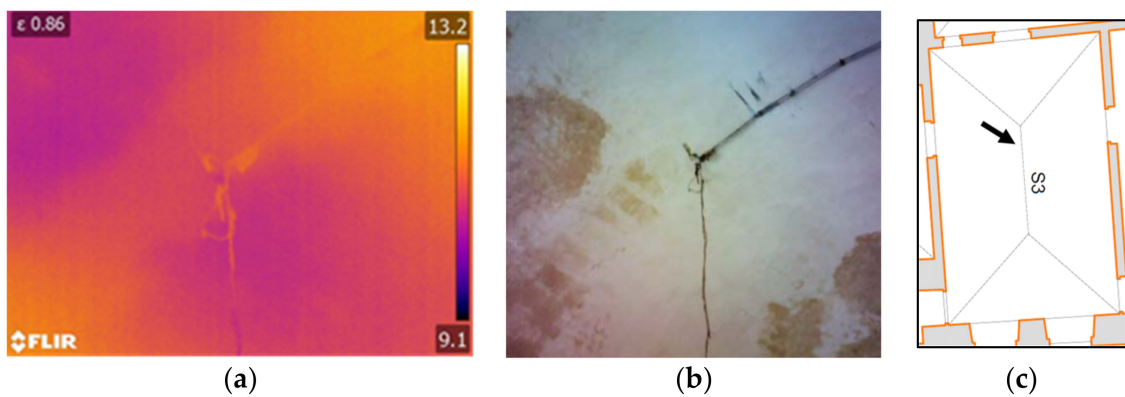
Figure 9. Room S3: (a) infrared image, (b) photography view and (c) plan view.

Above the calcarenite stone rows, the vault is made of elements in *terracotta*, i.e., the aforementioned “bubbole”. As already illustrated (Figure 5), they are characterized by a cylindrical shape (height of about 16 cm), internally hollow, closed at one end by a disc with a central hole (with a diameter of about 1 cm) and, at the other, by convex part with a small concave part in the center with another central hole. These “bubbole” are arranged with the disc towards the intrados of the vault and with the axis along the radials in order to lighten the vault according to a precise static logic. The presence of the “bubbole”, in addition to being visible in a few areas where there has been a detachment or deterioration of the plaster, is highlighted in numerous thermograms (Figures 7–10).

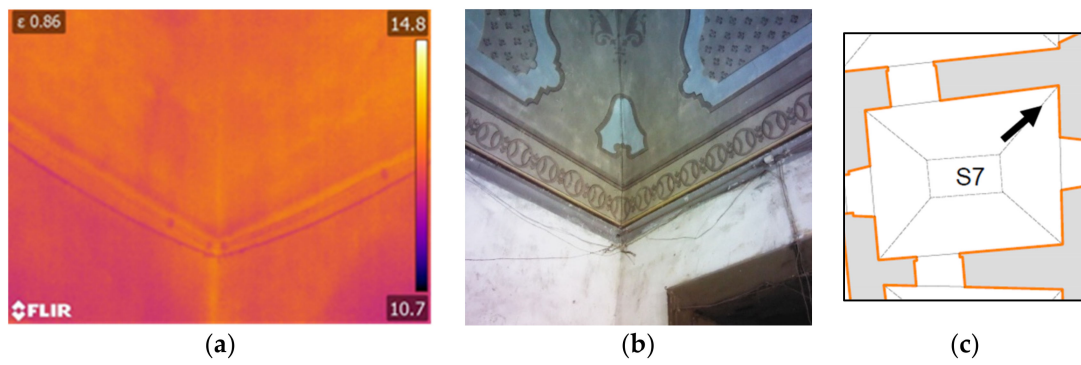
Figure 11. Room S7: (a) infrared image, (b) photography view and (c) plan view.

The keel vaults are characterized by semi-shells, which are portions of pavilion vaults, and, at the top, by a square or rectangular central plane made of a “flat” vault, i.e., a very low cloister vault (or with cloister vault head for a rectangular plan) probably levelled by the means of plaster layers. The thermographic investigation shows that these vaults are built with stone ashlar (room S7 in Figure 11, room S8 in Figure 12, room S9 in Figure 13 and room S10 in Figure 14). In some cases, the infrared survey makes evident some rows of calcarenite tufa starting from the vault impost. The thermograms of the flat central part do not show the presence of ashlar, probably due to the considerable thickness of the plaster. A change of color in the infrared is noted in the variation in the curvature to a flat configuration that is more affected by the heat exchange with the outside, uncovered in many parts (room S8 in Figure 12, room S9 in Figure 13 and room S10 in Figure 14).

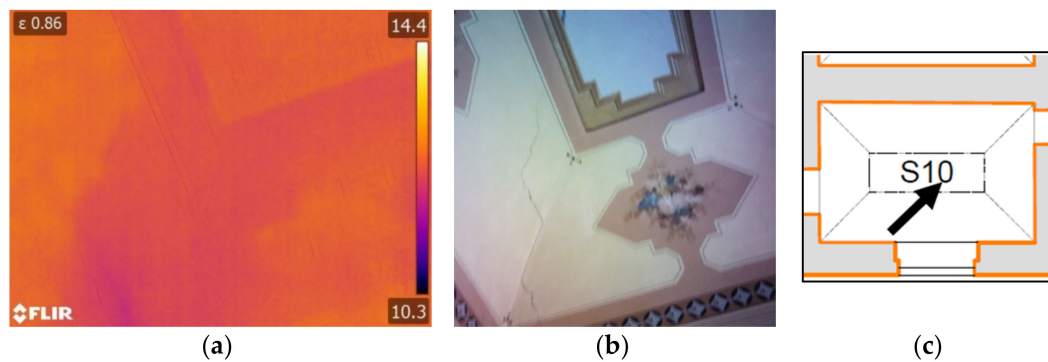
Figure 14. Room S10: (a) infrared image, (b) photography view and (c) plan view.

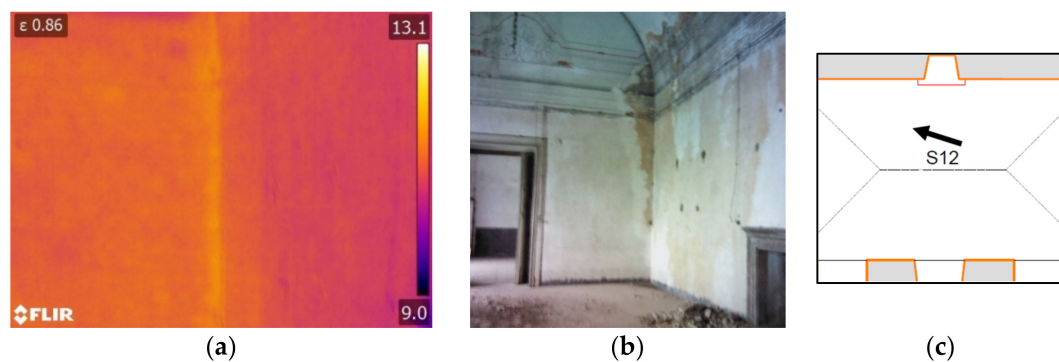
Figure 16. Room S12: (a) infrared image, (b) photography view and (c) plan view.

The so-called “camorcanna” system for the vaulted ceiling is only present in room S12 and it is partially collapsed, see Figure 15. It is made of reed mats tied with thread, arranged in a one-way direction and anchored to wooden ribs, which in turn are connected to the beams of the upper floor. A natural lime plaster was spread over the layer of reeds and then painted with frescoes (room S12 in Figures 16 and 17).

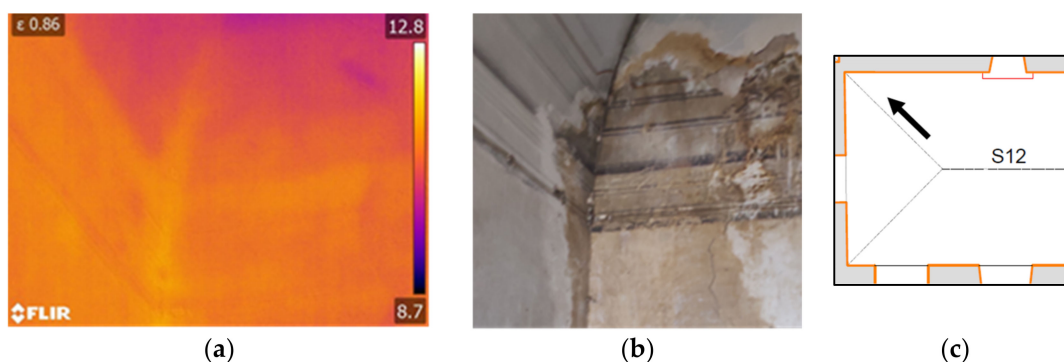
Figure 17. Room S12-bis: (a) infrared image, (b) photography view and (c) plan view.

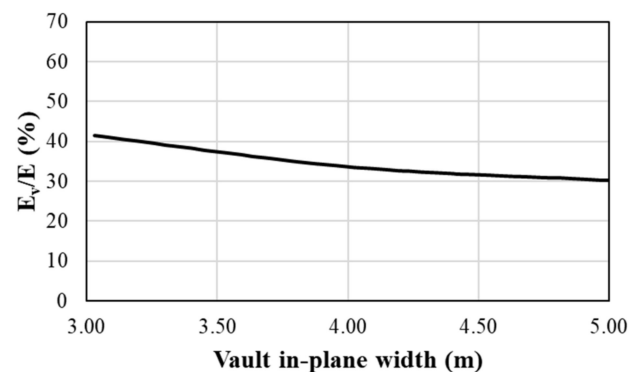
Figure 22. Equivalent Young’s modulus of vaulted roofs, according to [29] adapted with the permission of the authors.

vaults was assumed to be equal to wall masonry, while the “bubble” tangential modulus was assumed to be equal to half the one of the masonry vaults. In both cases, the equivalent modulus (E_v in Figure 22) was assumed to be equal to 30% of the material’s modulus. Three different models were adopted to perform modal analysis. The first model, namely, Infinite Stiffness Floor (ISF), considers every floor element with an infinite in-plane stiffness. On the contrary, the second one was made under the assumption that every floor element has no in-plane stiffness (namely, Zero Stiffness Floor, ZFS). In the third model, the in-plane stiffness was computed from data in Table 1 and it was labeled as Computed Stiffness Floor (CSF).

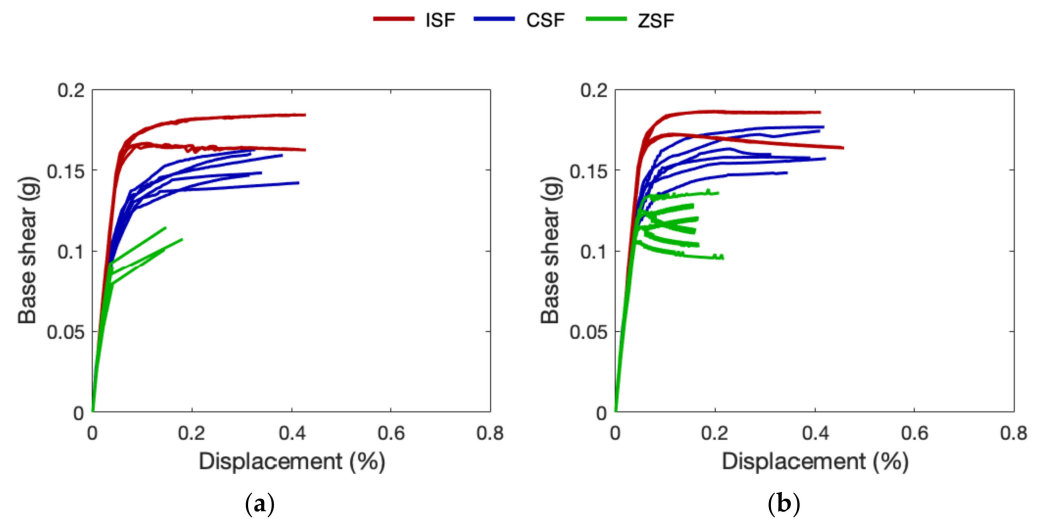
Figure 26. Pushover capacity curves of ISF_100, CSF_100 and ZSF_100 considering: (a) uniform distribution along X; (b) uniform distribution along Y; (c) static distribution along X; (d) static distribution along Y.

The same analyses were performed considering the masonry Young's modulus without any reduction. The capacity curves, collected in Figure 26, manifested a higher initial stiffness, as also shown in Figure 27. Despite the difference in shear capacity and ultimate displacement, the failure modes were not too different, with respect to ISF_50, CSF_50 and ZSF_50 models. The reduction in modulus was also applied to equivalent diaphragms representing the vaulted roofs. As displayed in Figure 27, the correlation between the material's modulus and the structure's equivalent modulus is almost linear. In other words, the reduction of 50% in material stiffness produces almost the same reduction in structure equivalent modulus.

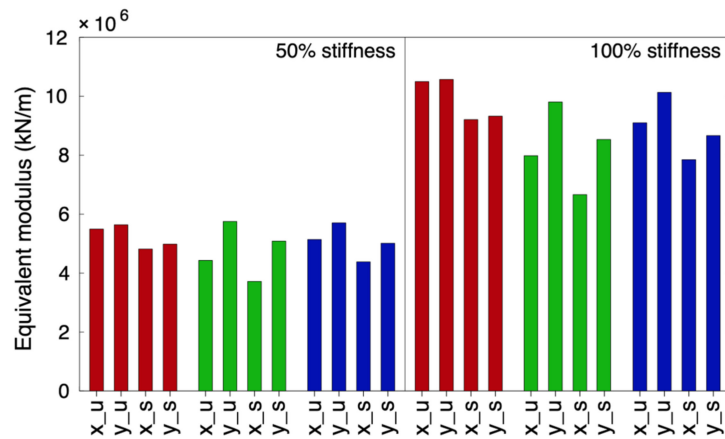
Figure 27. Equivalent modulus of the models considering different distributions of horizontal forces (x_u = uniform distribution along X, y_u = uniform distribution along y, x_s = static distribution along X, y_s = static distribution along Y).
